Eradicating Straight Pipes and Failed Systems in Kentucky

NESC STAFF WRITER
Caigan McKenzie

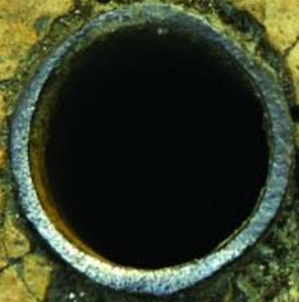
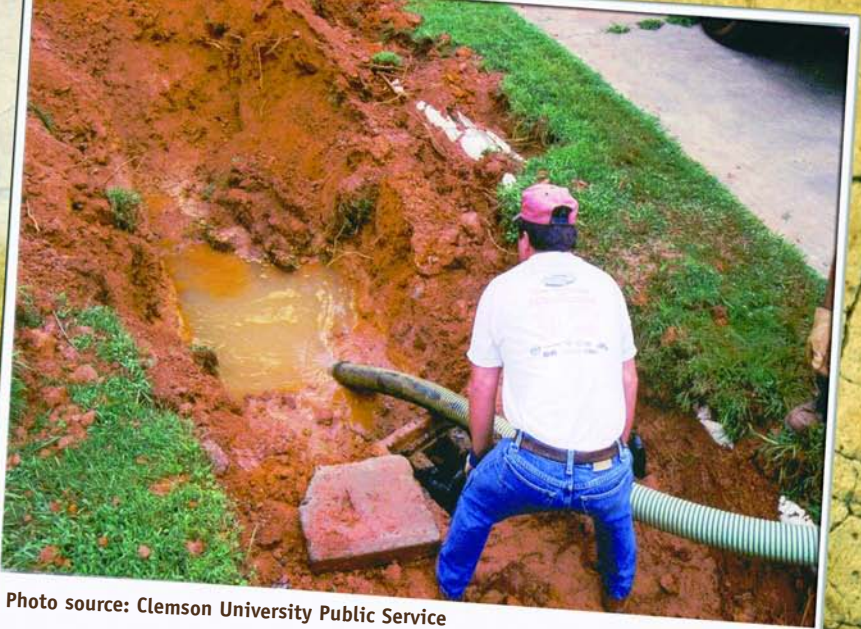
In Estill County, priorities for funding included the illimination of straight pipes, (below) and failed septic systems (right).

- **Priority 1:** straight pipes that emptied directly into a water source.
- **Priority 2:** straight pipes that emptied into wooded areas.

- **Priority 3:** failing septic systems coming to the top of the ground.
- **Priority 4:** working septic systems over 10 years old.

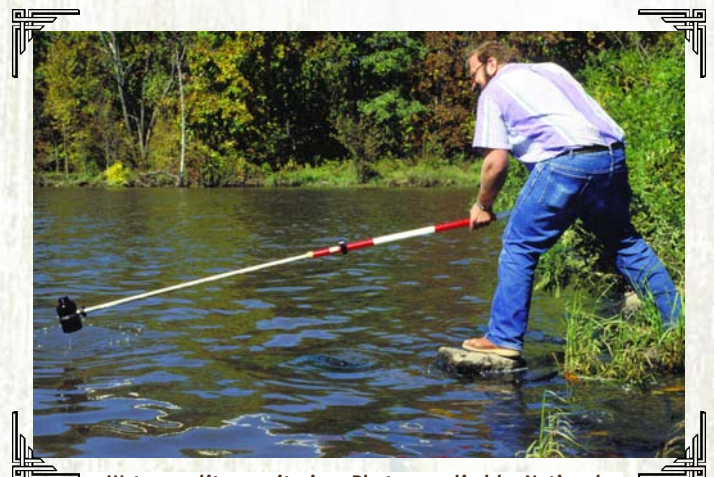
Water quality monitoring. Photo supplied by National Resources Conservation Service (NRCS).

The bottles used to collect samples were sterile, plastic bottles, each containing a sodium thiosulfate tablet. Stream bacteria samples were collected using the surface-grab technique. One hand grasped the bottle and plunged it mouth down 6 to 12 inches below the surface of the water, with the mouth positioned upstream into the current. Each bottle was filled to approximately 75 percent capacity and was free of debris, surface scum, and bottom sediment.
